## Outstanding Projects of 2004

## Mud Creek BMP Implementation Project

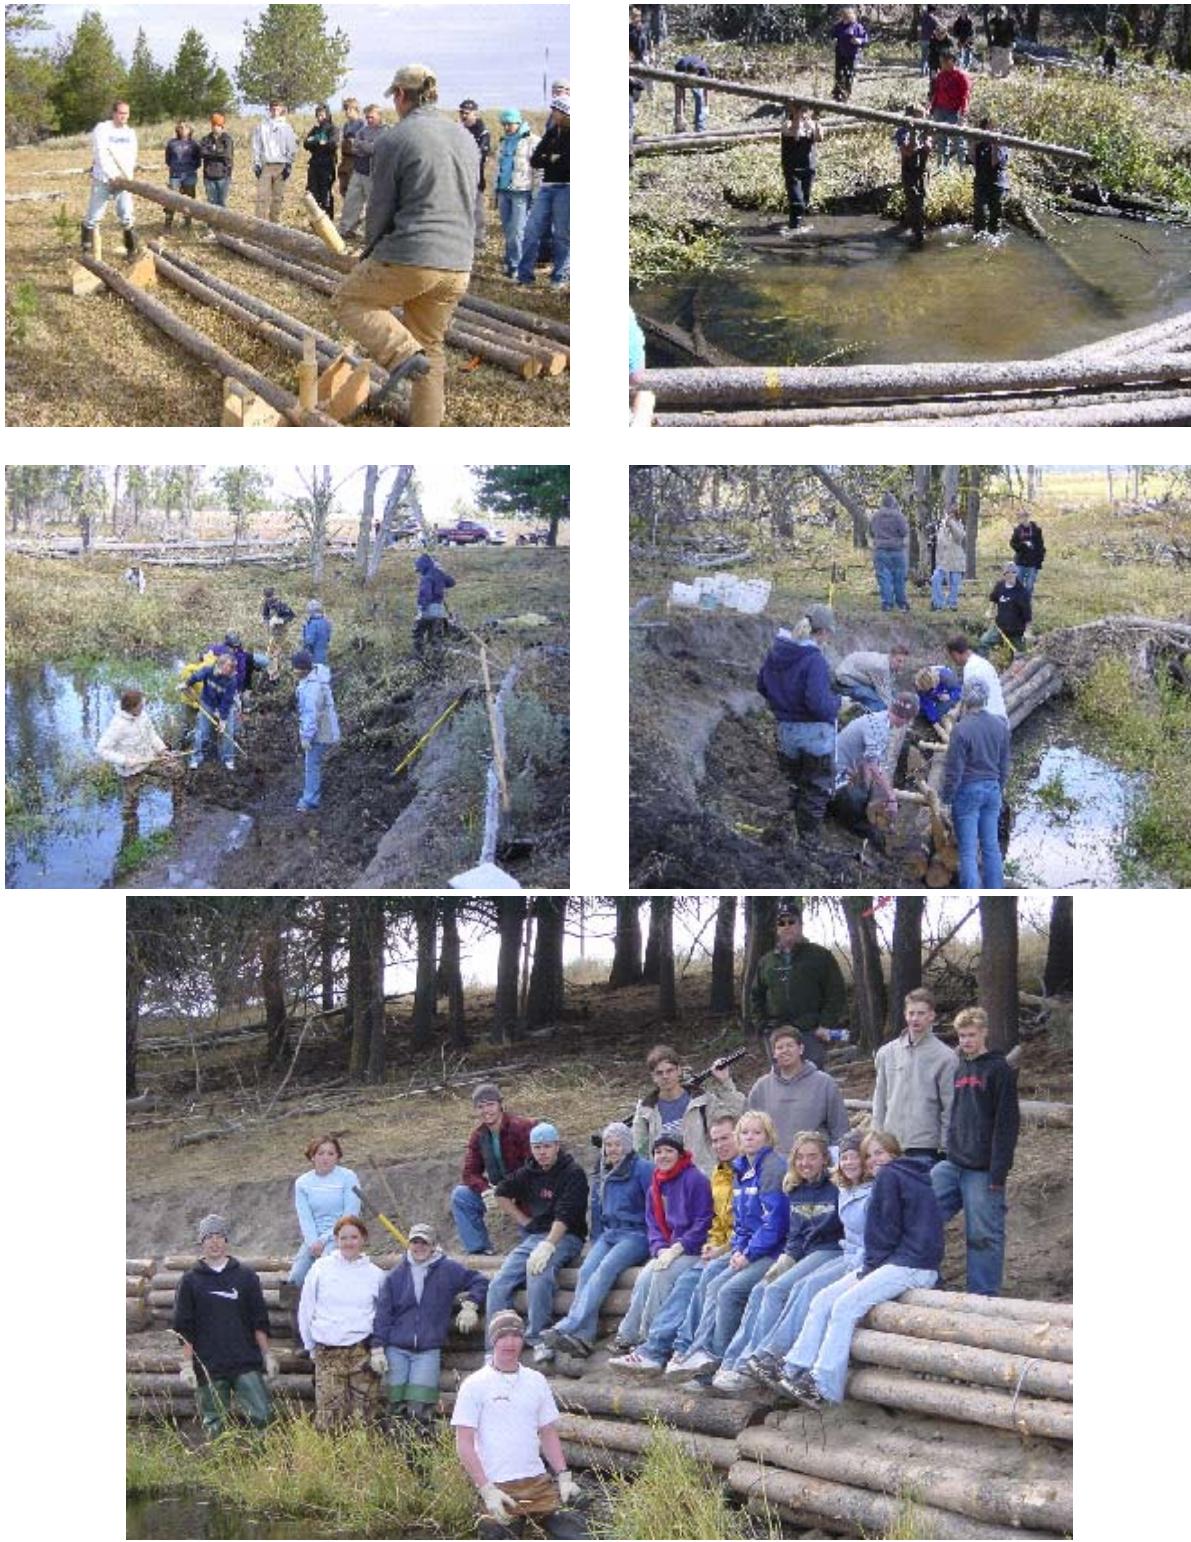
Figure 30. Students installing ELWd Structures along Mud Creek.

- **Stream bank stabilization**—Seventeen ELWd® structures—engineered alternatives to woody debris—were installed on seven badly eroded banks in October 2003 by forty students from the advanced biology class at Cascade High School. These structures will stabilize stream banks, reduce soil erosion, and restore stream morphology.

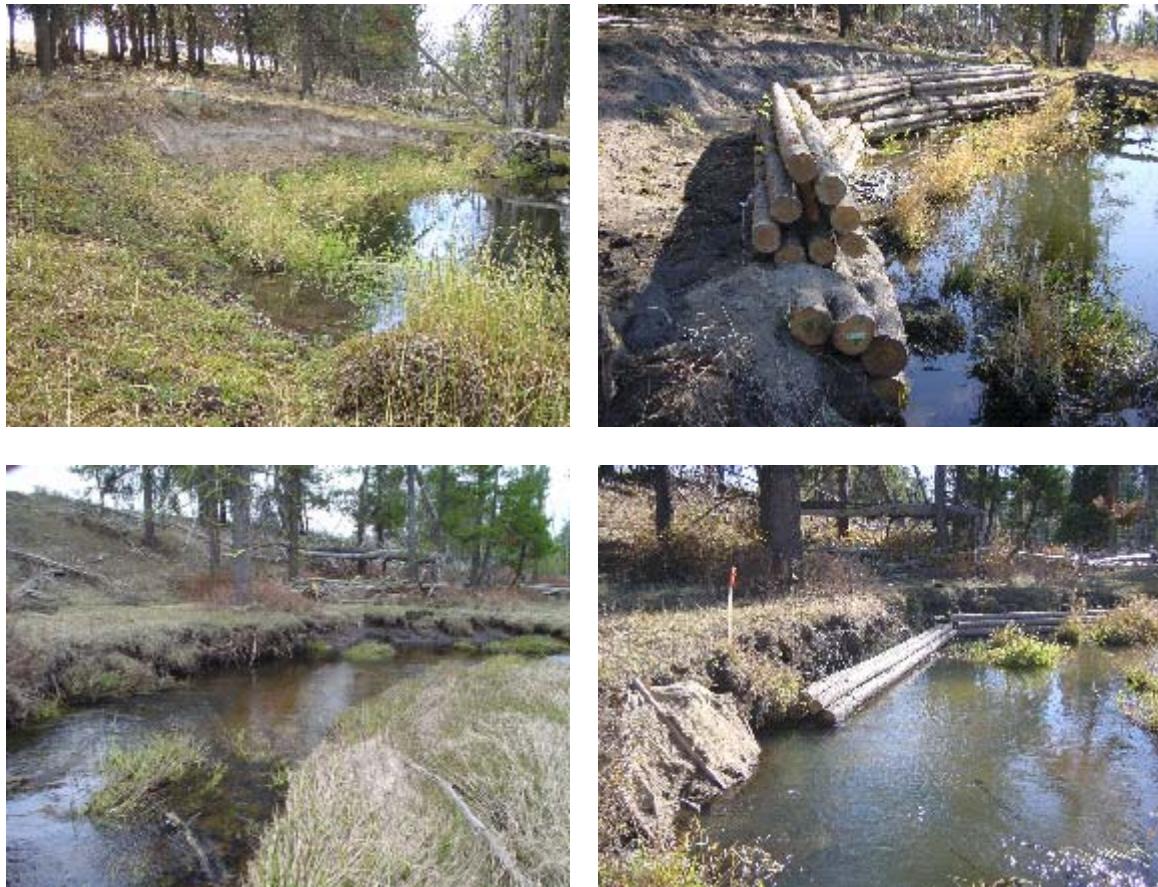
Figure 31. Mud Creek stream bank before and after ELWd Structures were installed.

- **Riparian herbaceous cover**—About 230 native willows and alders, with established six-inch root systems, were planted in and around the ELWd Structures in late October 2003. The establishment of woody plants provides erosion control, consumes soil and water borne chemicals and nutrients, provides passerine habitat and ungulate cover, and decreases water temperatures. Once the ELWd structures erode away (in about ten years), the willow root systems will continue to stabilize the banks.
